## Final Loss Report (sample)

| <b>Insured:</b> | [Removed] | <b>Date of Loss:</b> | 9/11/2017 |
| <b>Location:</b> | Gwinnett County, GA | <b>Type of Loss:</b> | Wind (Hurricane Irma) |

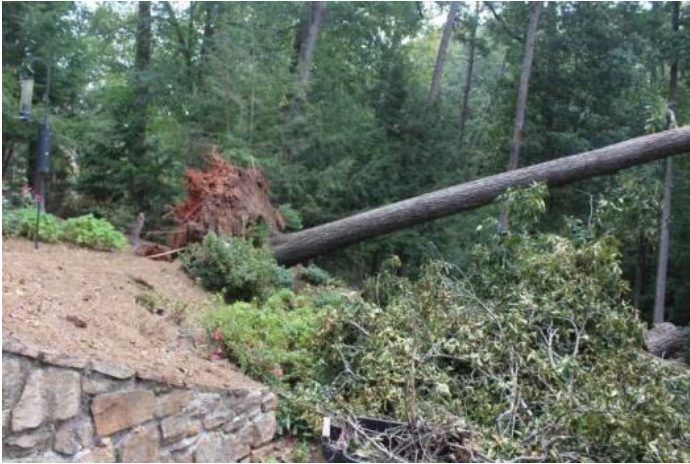
**Photo 1**

Uprooted tree

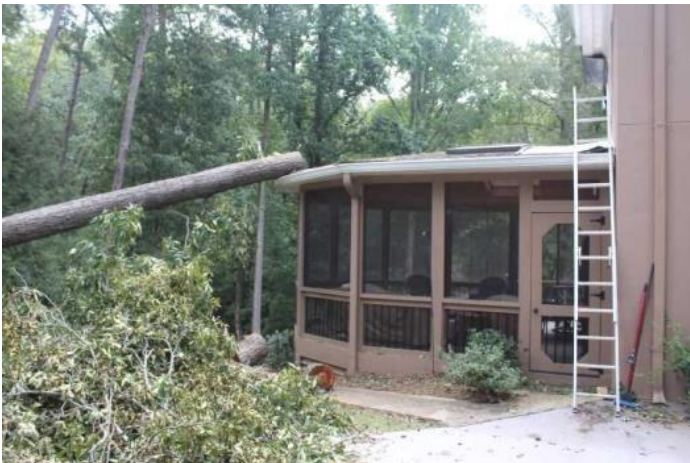
**Photo 2**

Tree fell across the back porch roof

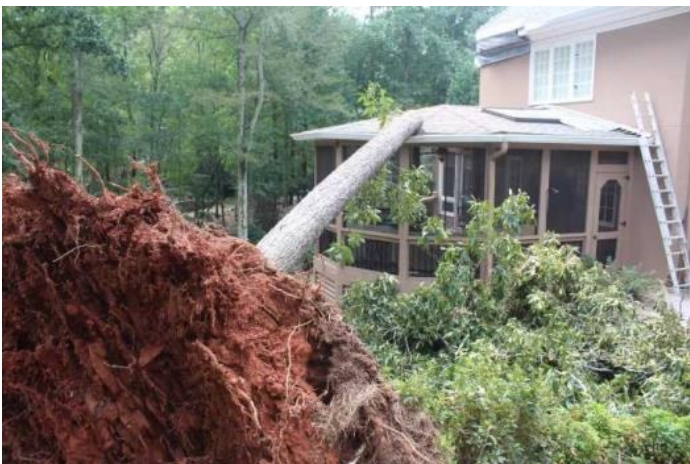
**Photo 3**

View from stump to dwelling

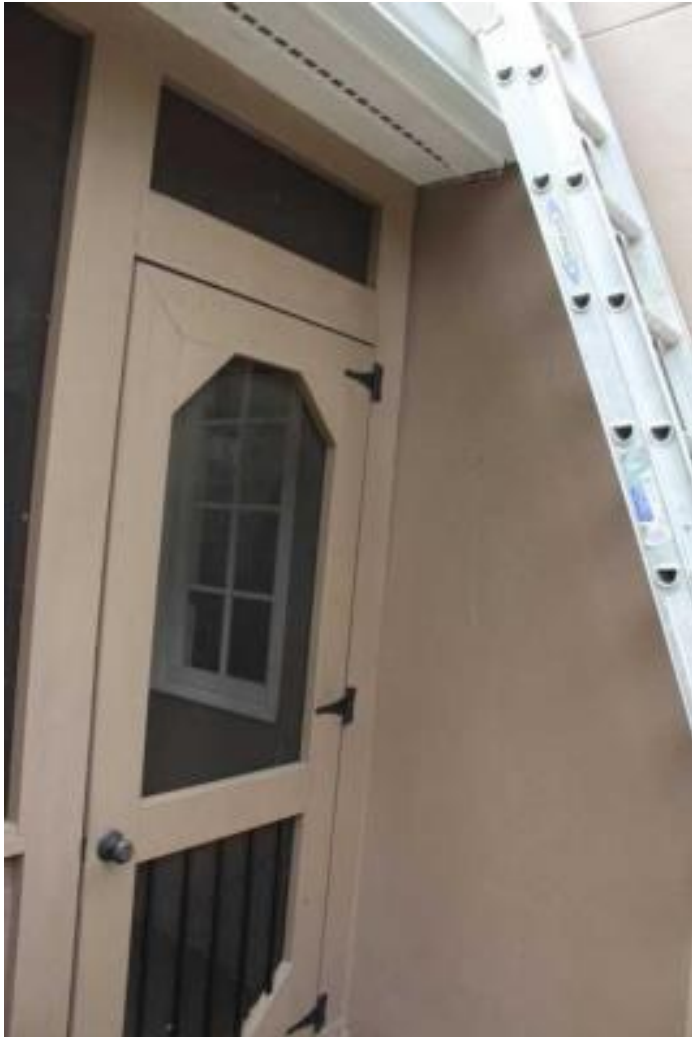
**Photo 4**

A large tree was uprooted during the storm and fell across the rear elevation. The screened-in porch was struck, knocked out of square and pulled away from the dwelling wall. The porch roof was twisted; its framing will need to be rebuilt and the walls squared and set. The porch interior is finished with stained and sealed pine boards, and the ceiling boards will need to be removed and replaced when the roof is reframed.

The impact shifted the porch and pulled it away from the wall

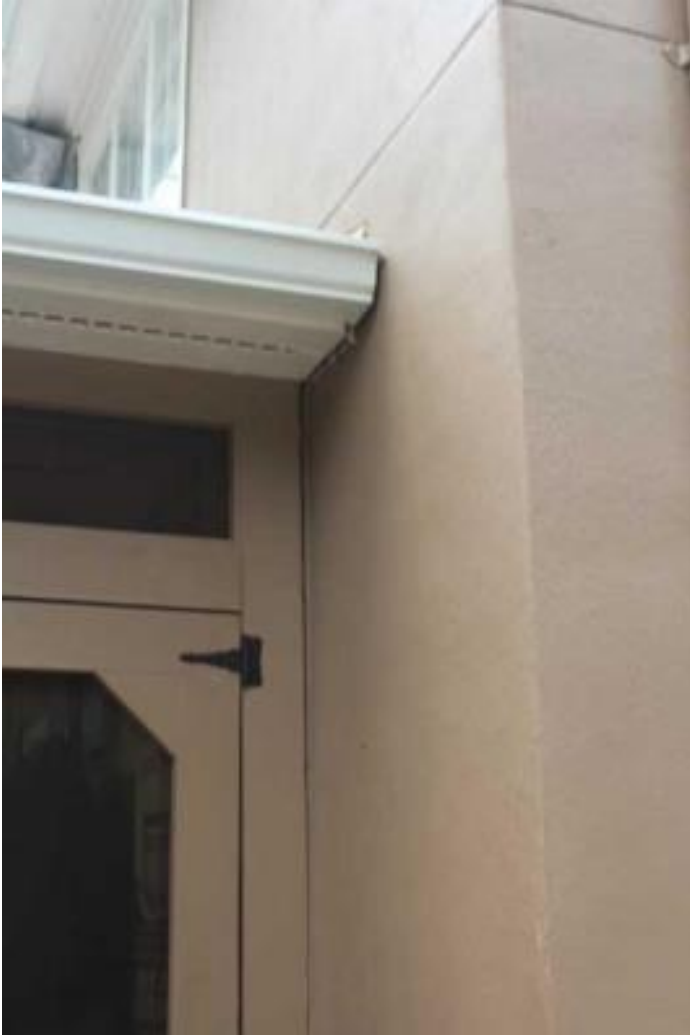
**Photo 5**

Porch pulled from the wall

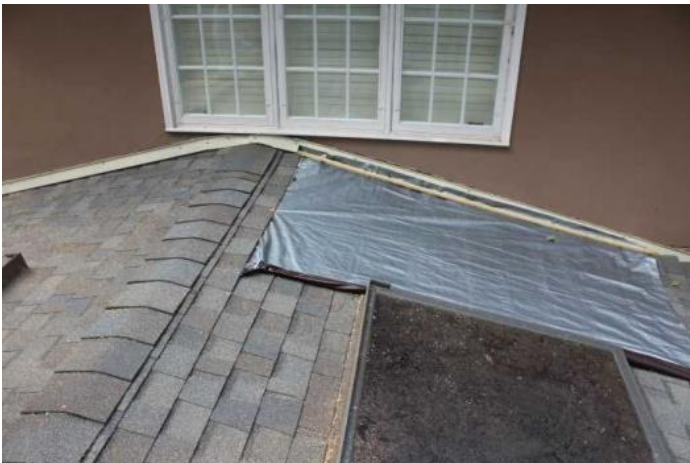
**Photo 6**

Tarp was installed over opening

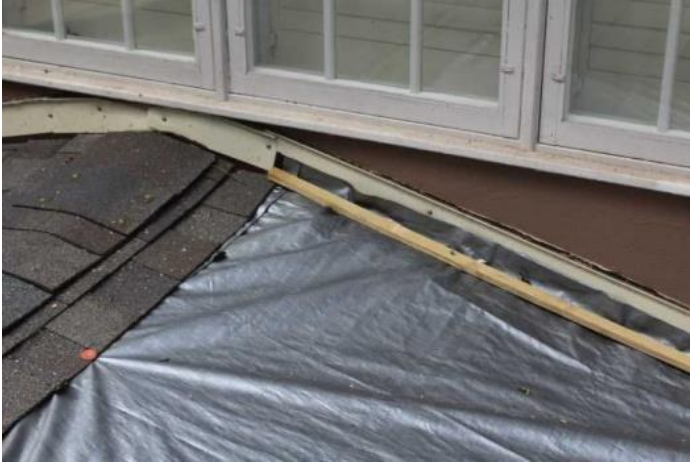
**Photo 7**

Gap where porch roof was pulled away from the main dwelling

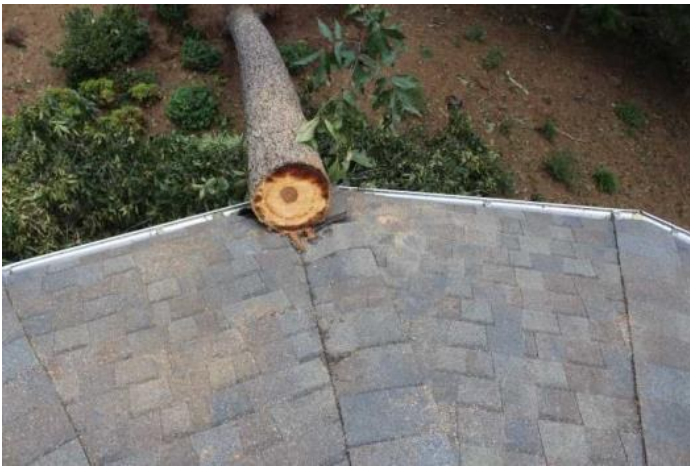
**Photo 8**

Part of tree still leaning on porch roof

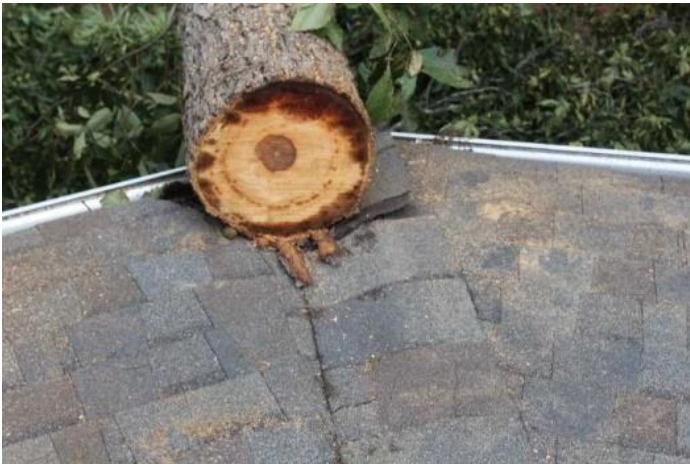
**Photo 9**

Framing crushed beneath the tree

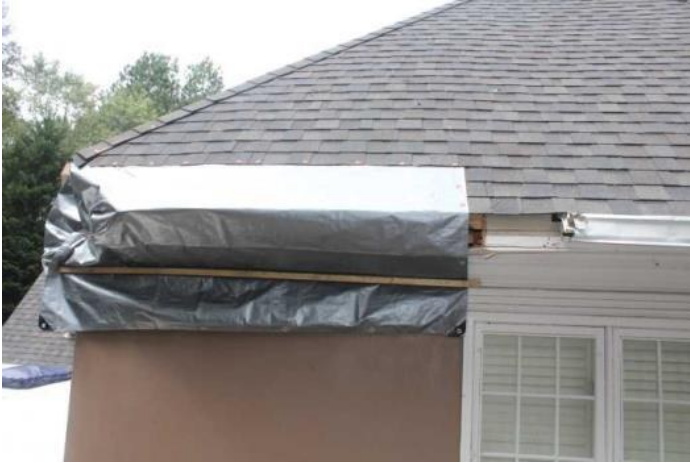
**Photo 10**

Soffit, fascia, trim, and gutters ripped off

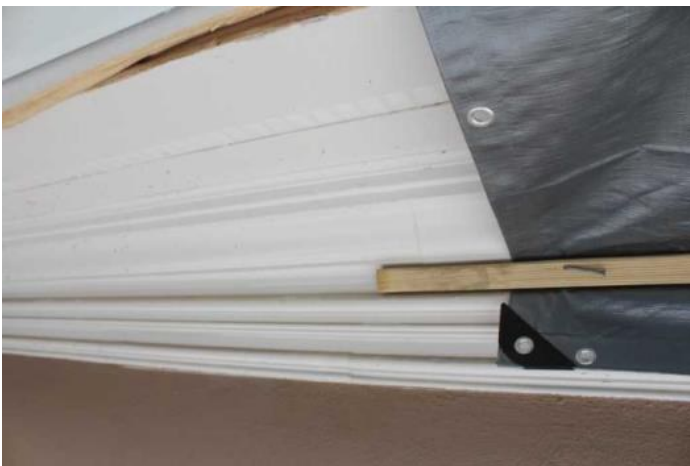
**Photo 11**

Milled-out trim along the exterior beneath the soffit

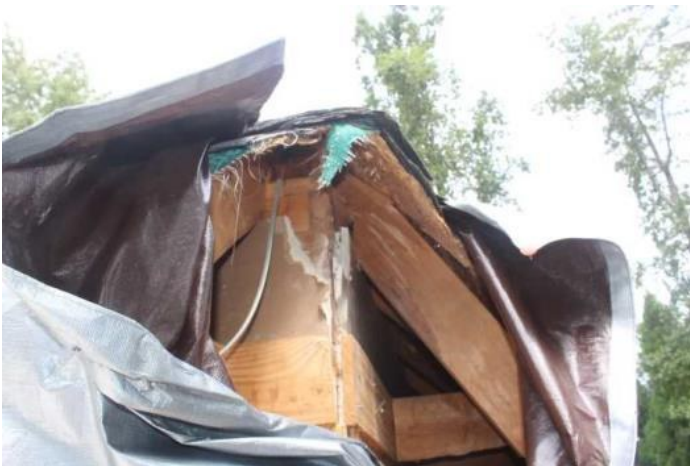
**Photo 12**

The top half of the tree fell across the back slope of the hip roof and the flat rubber membrane roof. Several king rafters were snapped off at the end of the hip, along with custom fascia and soffit work. To repair the broken rafters properly they must be tied in at least 4 ft up the slope, which requires removing and replacing more of the one-year-old architectural shingles on the back and right slopes. The gutters along the rear elevation were also damaged.

Rafter ends were snapped and some decking damaged

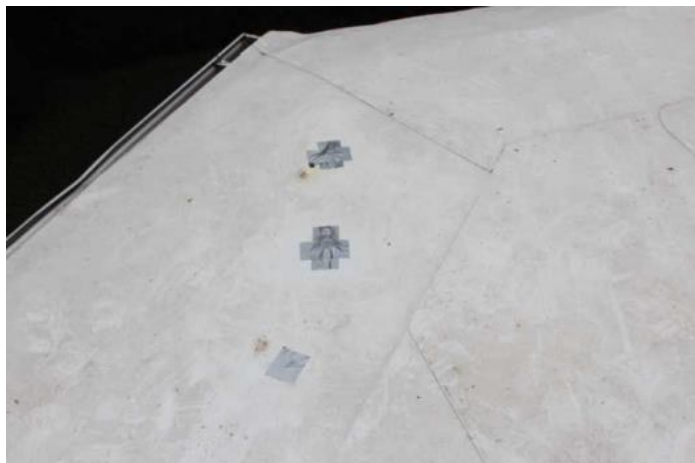
**Photo 13**

Multiple holes punched through roofing

Several holes were punched through the rubber membrane roof and into the sunroom, and water was pooling beneath the membrane. The membrane roof will be removed and replaced, running 3 to 4 ft up the back slope of the shingle roof, with some sheathing replaced. Two of the three identical skylights on this roof were directly damaged; we allowed the third as well because they are an older matching set. Repairs along the rear and left elevations will require scaffolding.

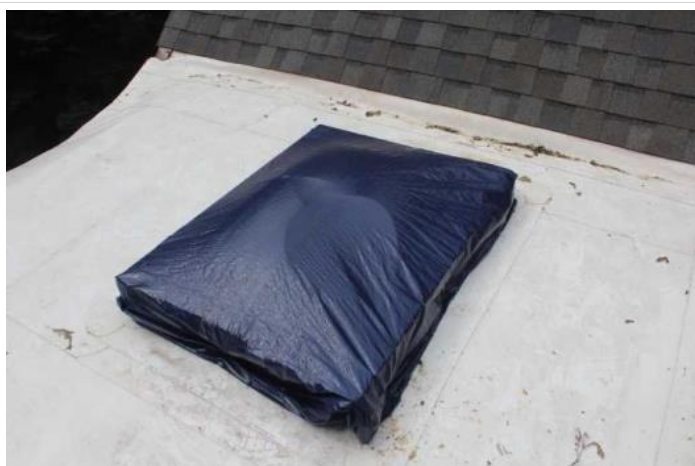
**Photo 14**

Busted skylight

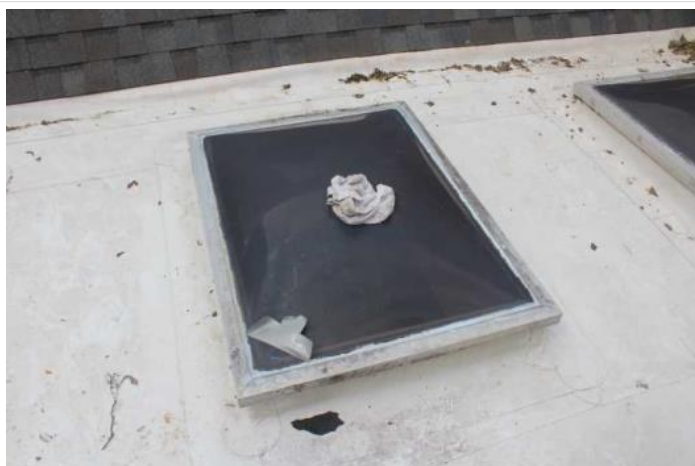
**Photo 15**

This dome was cracked

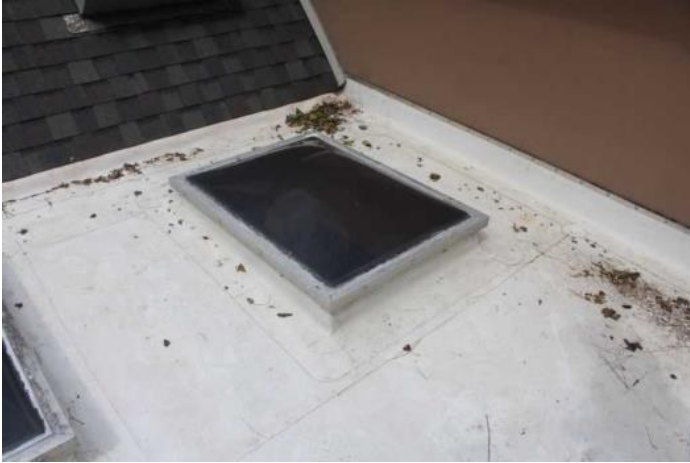
**Photo 16**

The third skylight wasn't damaged but is one of 3 identical skylights, so it will need to be replaced as well for a uniform finish

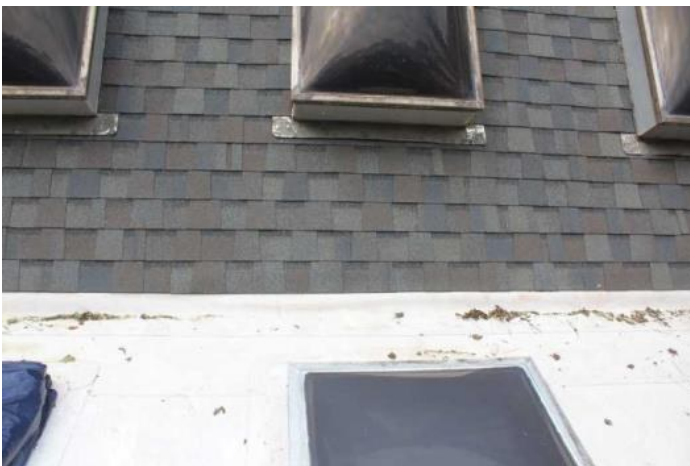
**Photo 17**

About 3' of shingles will be detached and reset to facilitate repairs to the rubber roofing

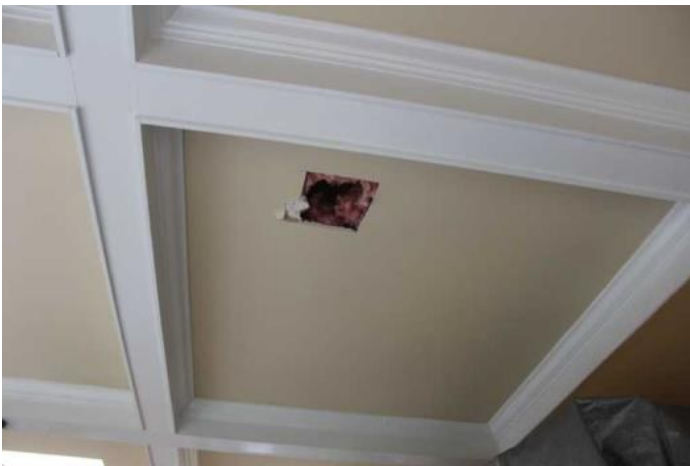
**Photo 18**

Openings cut in drywall where water was pouring out

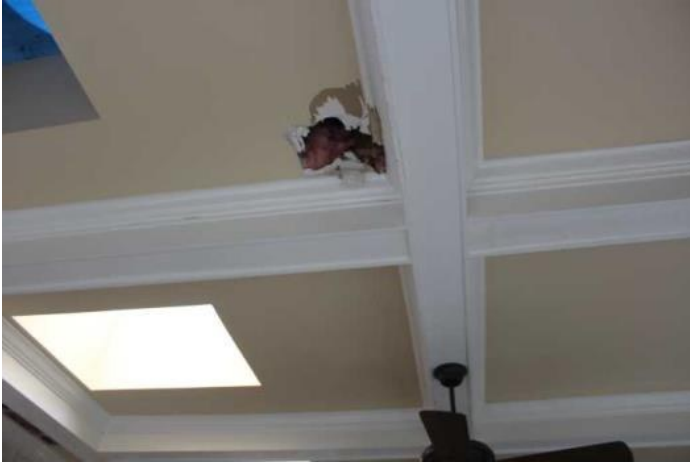
**Photo 19**

In the sunroom, water stains ran along the custom box beam ceiling trim and water was pouring from the seams. The box beam trim, damaged drywall and insulation will be replaced and painted. Water also ran down the walls and onto the tile floor, which had begun to crack at the time of inspection.

Staining on the box beam trim and a hole where a branch punched through

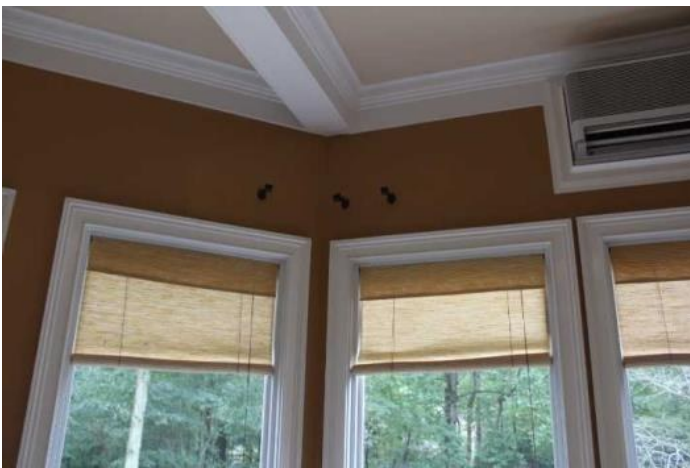
**Photo 20**

Water was pouring down inside of this wall

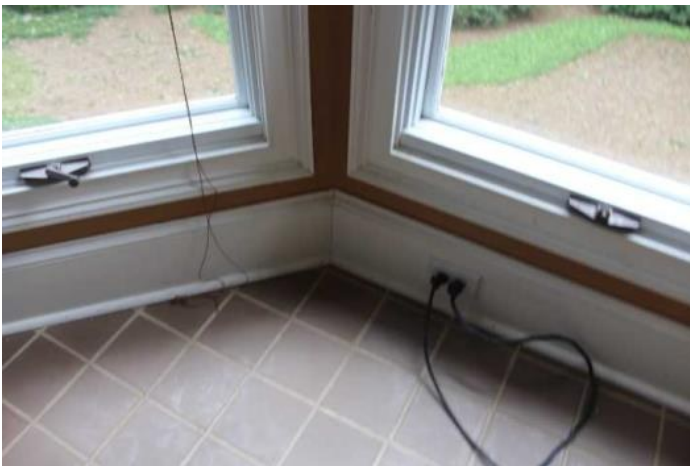
**Photo 21**

Water ran down to the floor and the oversized base is pulling apart at the seam

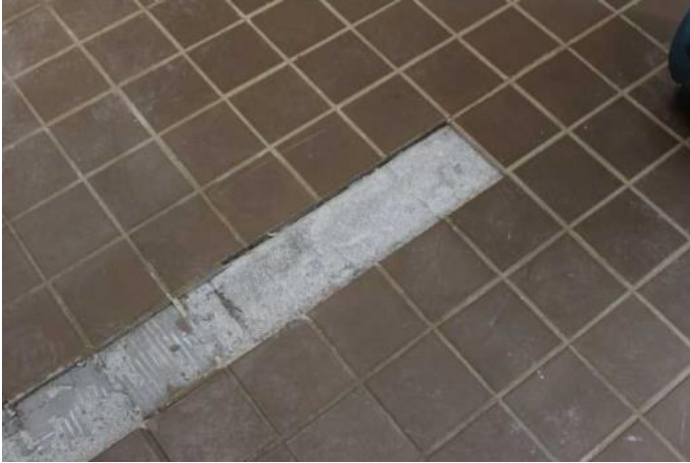
**Photo 22**

Cracked tiles removed

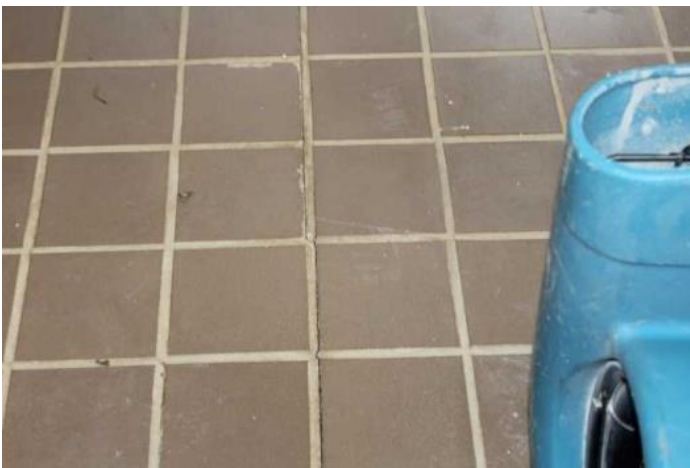
**Photo 23**

The jolt to the room cracked the tile floor

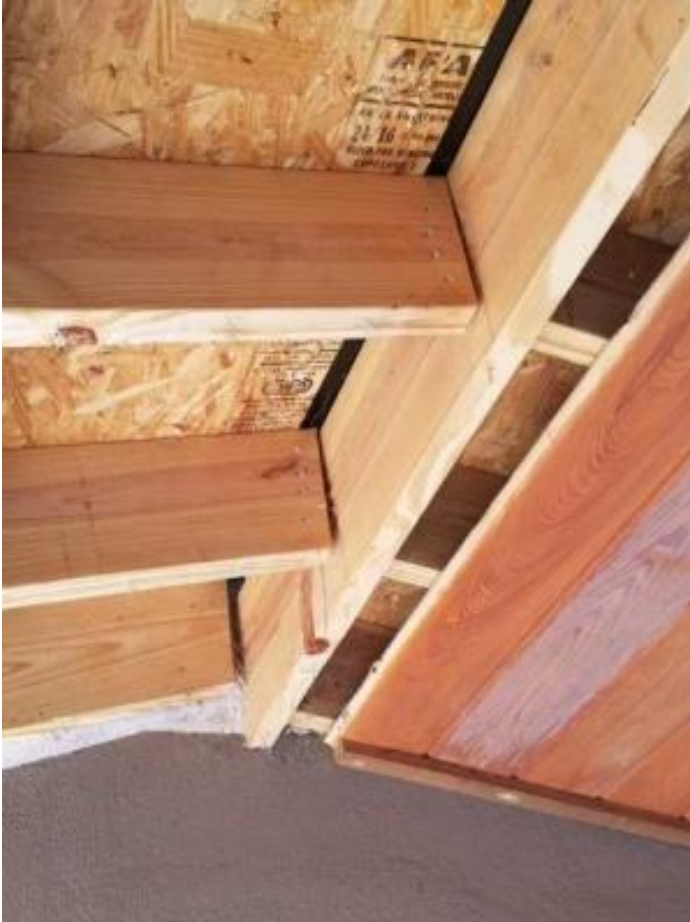
**Photo 24**

Photo supplied by the homeowner after inspection: porch roof structure. The main ridge beam is cracked and the rafters are twisted and pulled loose.
