## Final Loss Report (sample)

| <b>Insured:</b> | [Removed] | <b>Date of Loss:</b> | 9/11/2017 |
| <b>Location:</b> | DeKalb County, GA | <b>Type of Loss:</b> | Wind (Tropical Storm Irma) |

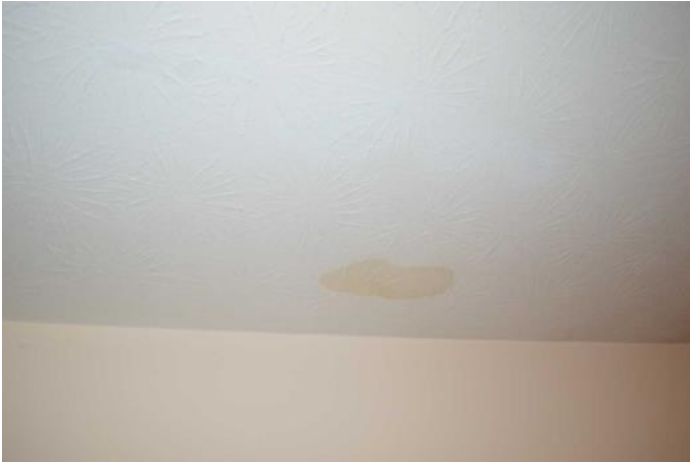
**Photo 1**

Upstairs rear bedroom: water stain on the ceiling

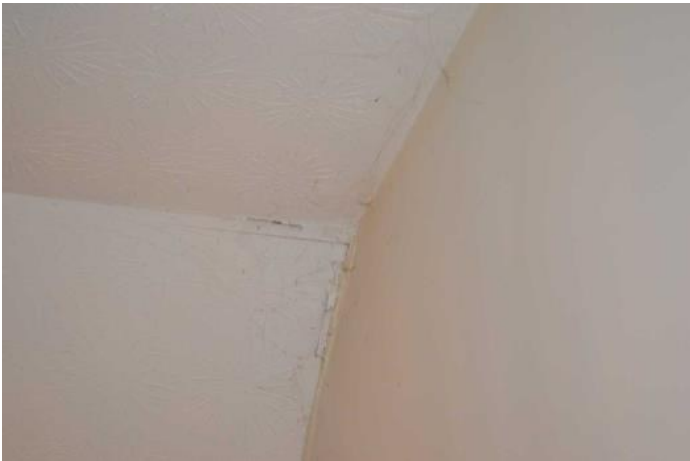
**Photo 2**

Water damage in the upstairs overlook and hall

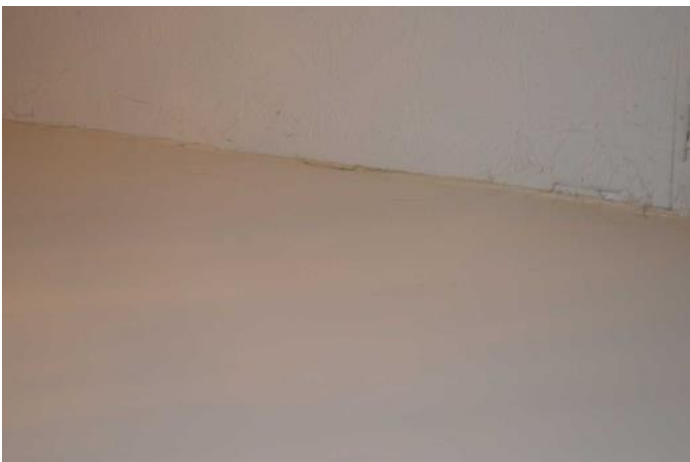
**Photo 3**

Overlook and hall: staining along the ceiling line

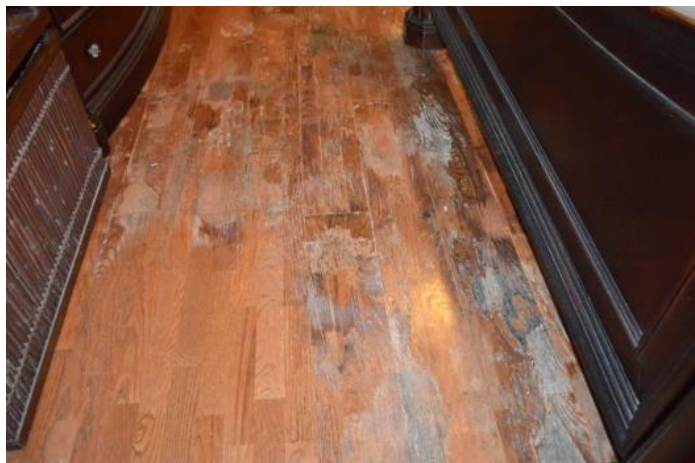
**Photo 4**

Engineered wood floor in the main-floor rear bedroom. The insured was away for two weeks, found water on the floor and sprayed bleach on it

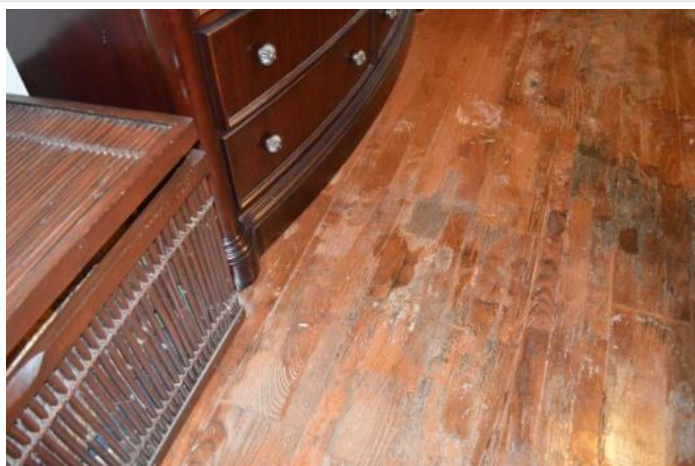
**Photo 5**

Bedroom floor damage

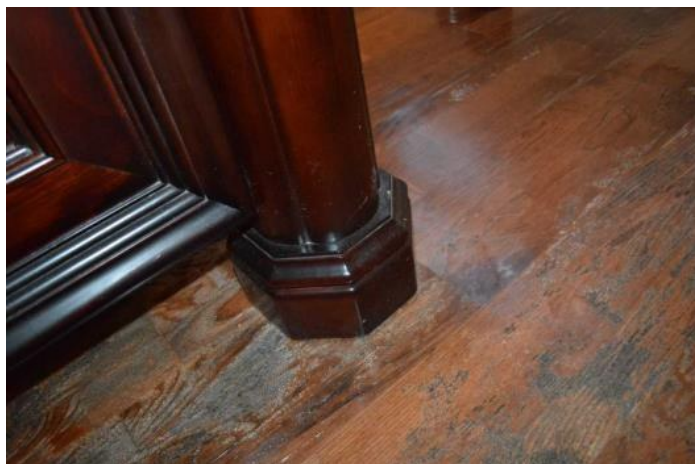
**Photo 6**

Bedroom furniture inspected: no damage to any of the wood

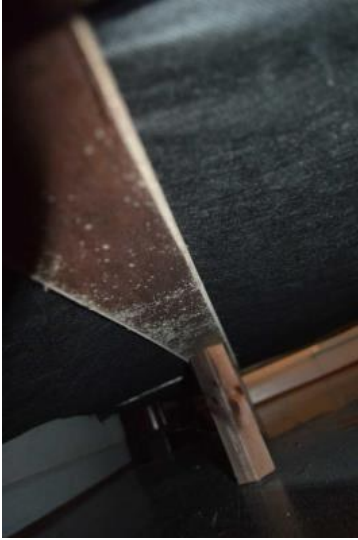
**Photo 7**

Under the bed: the wood will need cleaning, and mildew was forming on the bottom of the box spring, which will need replacing

Personal property: we checked the wood furniture in the bedroom and found no damage where it touches the floor. Under the bed, mildew is forming on the slats beneath the box spring. We are including cleaning the bed and replacing the box spring, and cleaning the other pieces in this room that sat on the floor and one piece in the den.

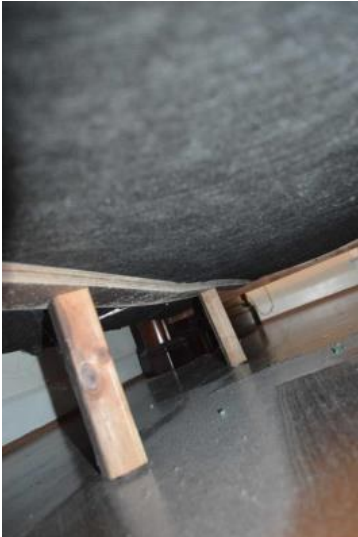
**Photo 8**

Under the bed (continued)

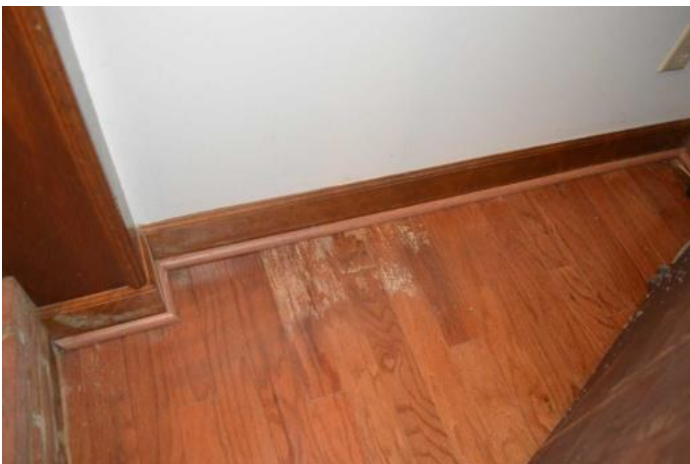
**Photo 9**

Den, opposite side of the fireplace from the bedroom: water damage to the floor

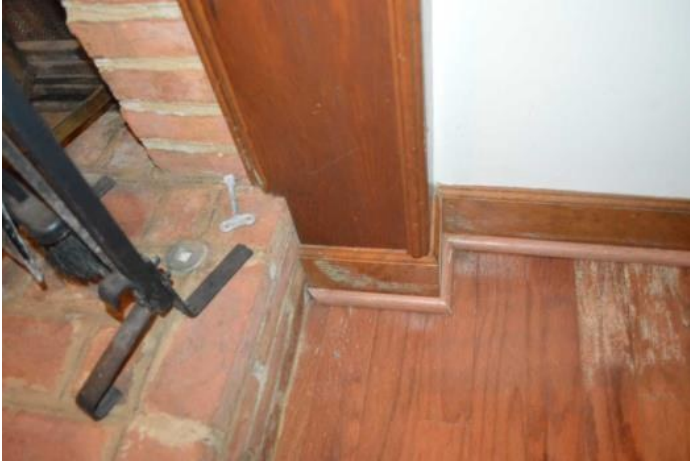
**Photo 10**

Den floor at the fireplace hearth

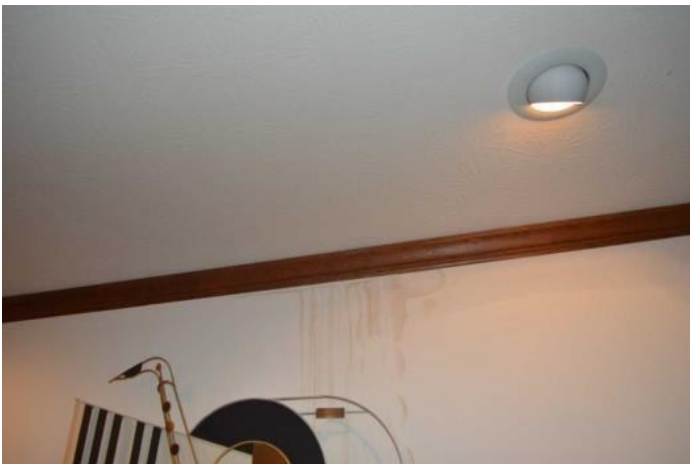
**Photo 11**

Den: water damage to the drywall

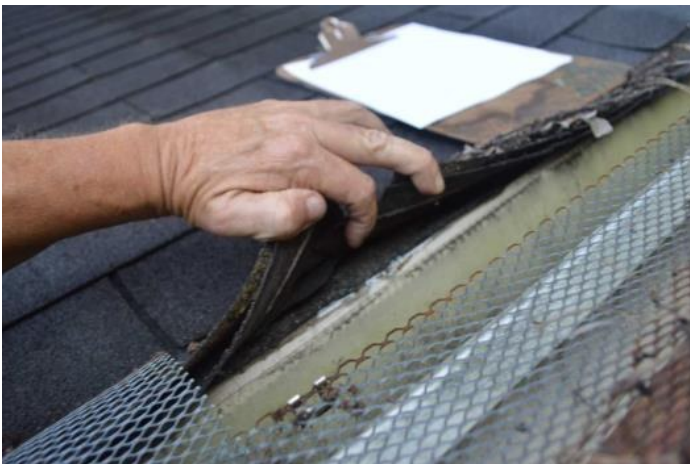
**Photo 12**

25-year shingles, no drip edge, two layers. Georgia code now requires drip edge and valley flashing (IRC R905.2.8.5 and R905.2.8.2)

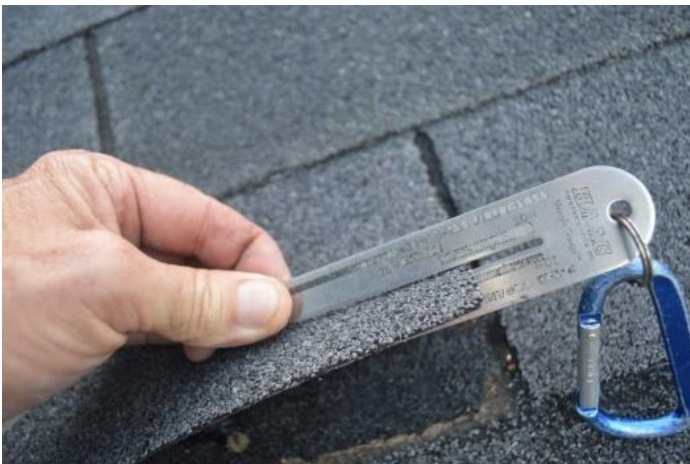
**Photo 14**

25-year 3-tab shingles, 15 years old

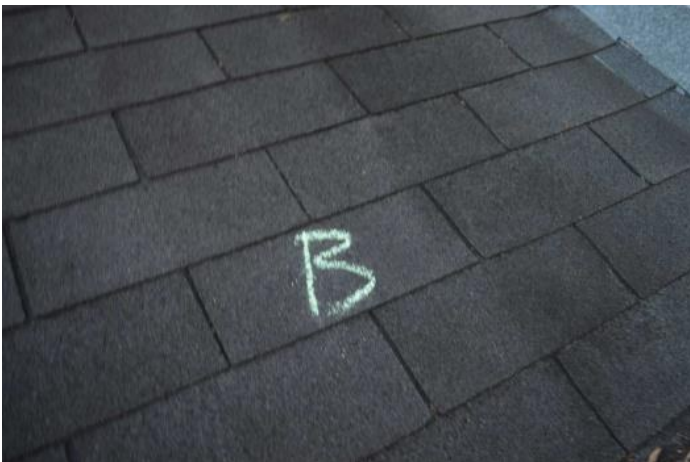
**Photo 15**

Brittle test: shingles failed and are too brittle for repair

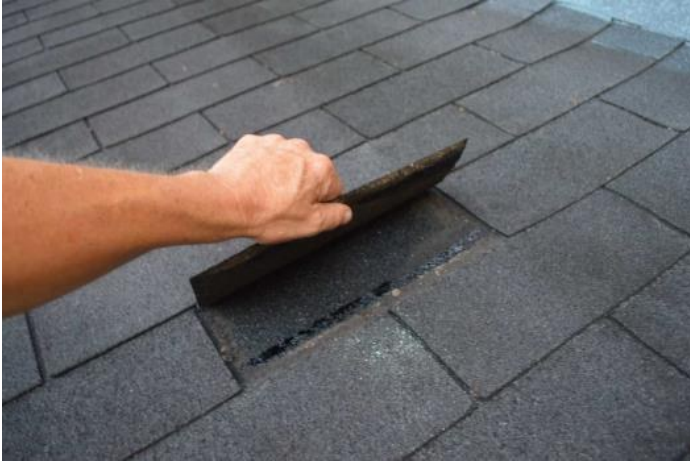
**Photo 16**

Brittle test (continued)

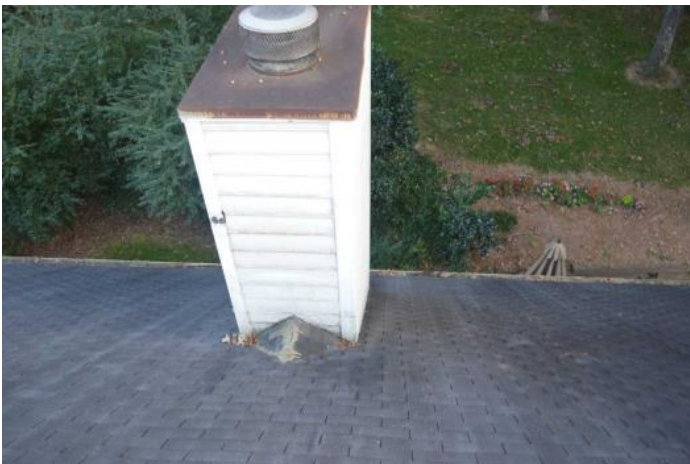
**Photo 17**

Our inspection found that the water in the den and bedroom resulted from wear and tear around the chimney and its flashing, together with windstorm damage to the roof and ensuing water damage, all occurring in the same event.

Chimney area where the leaking into the bedroom and den occurred

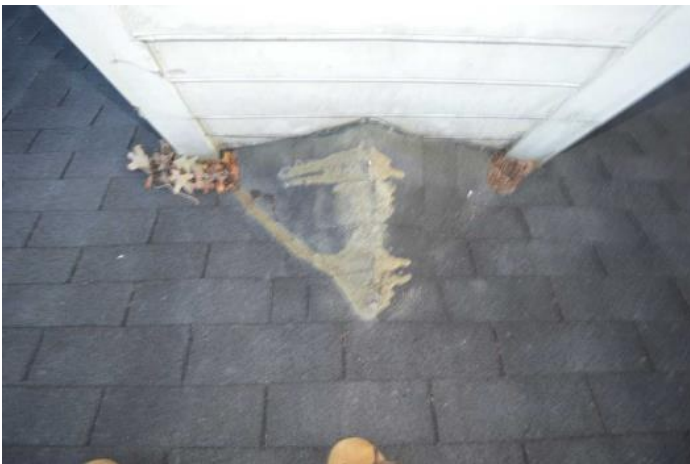
**Photo 18**

Chimney flashing: wear and tear issues

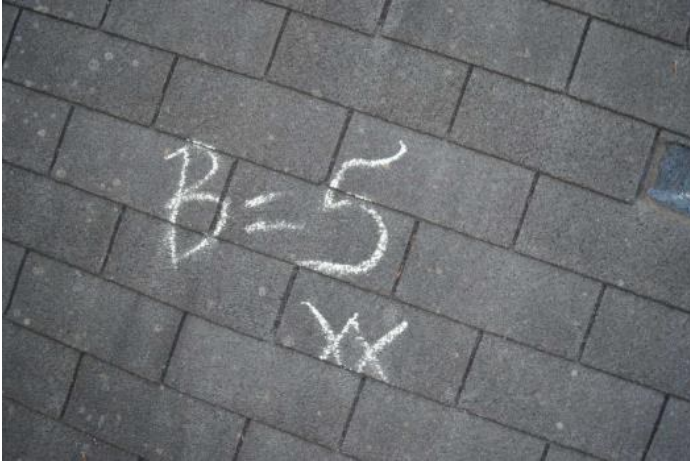
**Photo 19**

Back slope: 5 wind-damaged shingles

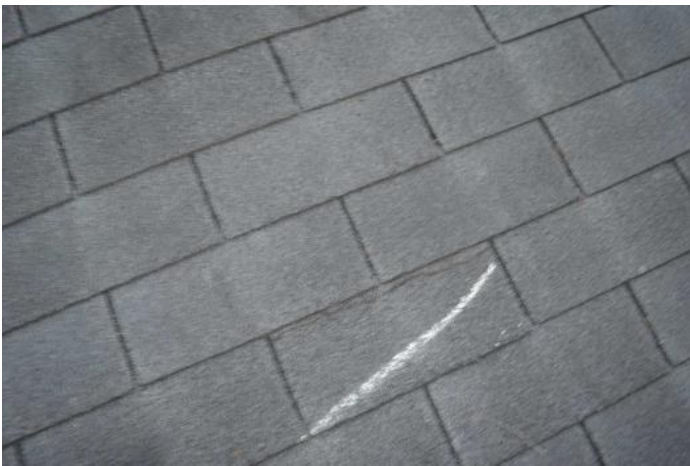
**Photo 20**

Back slope: wind-damaged shingle

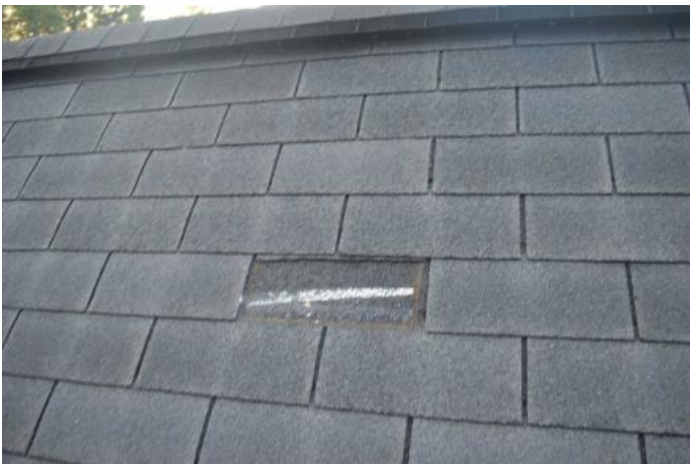
**Photo 21**

Back slope: wind-damaged shingle

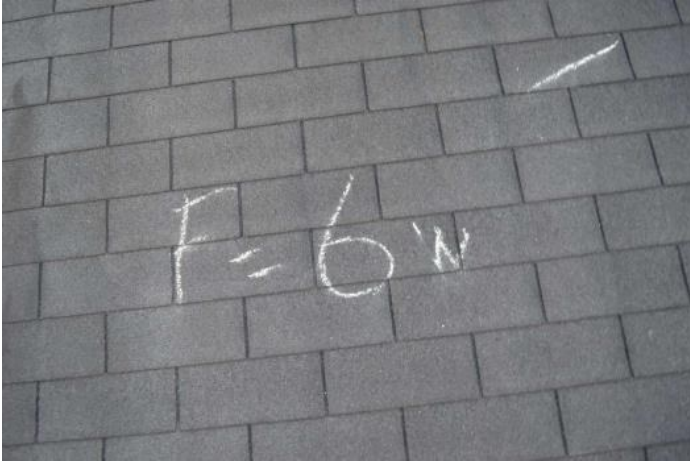
**Photo 22**

Front slope: 6 wind-damaged shingles

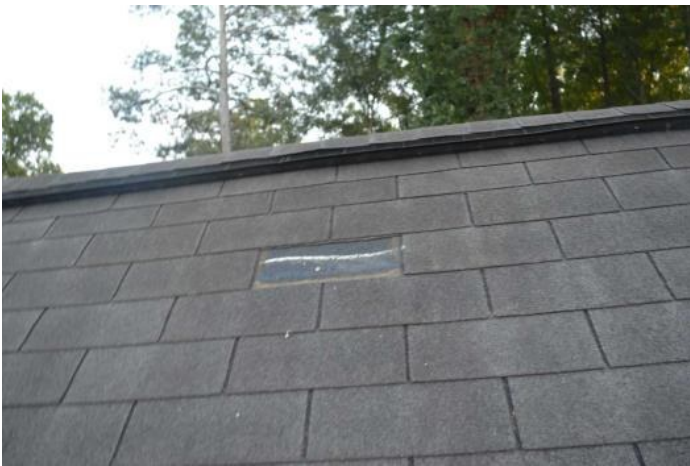
**Photo 23**

Front slope: wind-damaged shingle

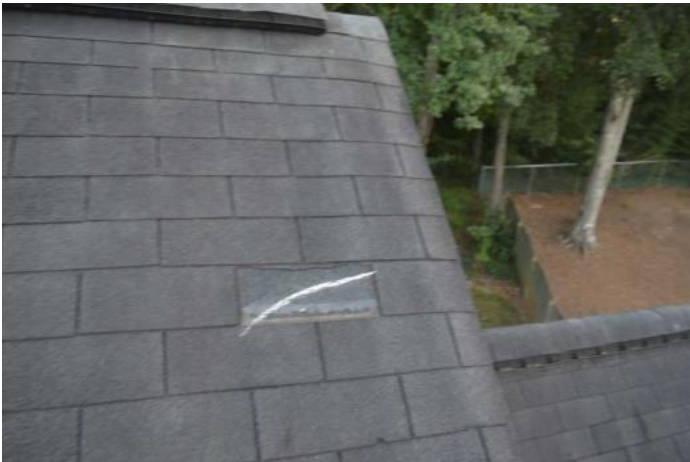
**Photo 24**

Front slope: wind-damaged shingle
