## First Report (sample)

| <b>Insured:</b> | [Removed] (interstate motor carrier, 226 power units) | <b>Date of Loss:</b> | 1/9/2025, 2:41 pm CT |
| <b>Location:</b> | Eastern Blvd at the I-85 entrance, Montgomery, AL | <b>Type of Loss:</b> | Two-vehicle intersection collision |

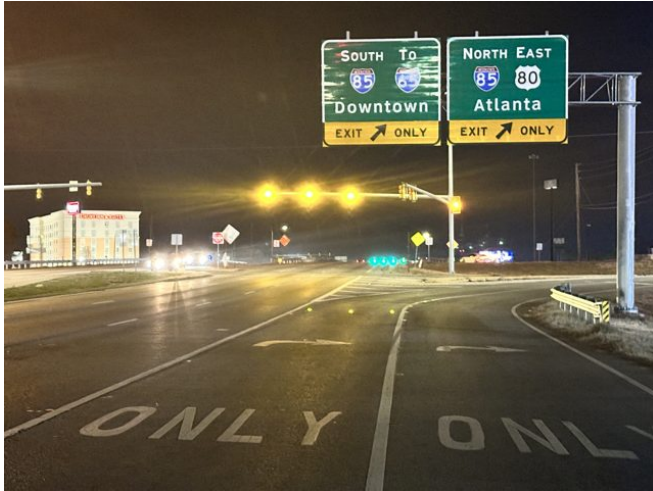
**Photo 1**

Southbound Eastern Boulevard at the interchange:  
overhead guide signs for the I-85 entrance lanes.

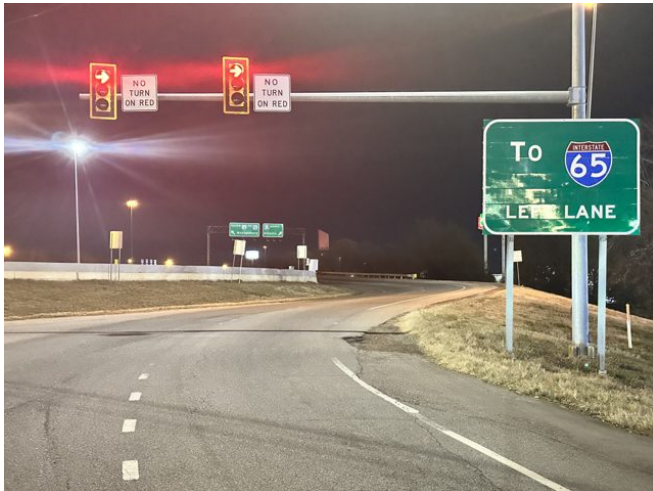
**Photo 2**

Signal heads for the southbound left-turn lane toward the  
interstate, with "No Turn on Red" signs.

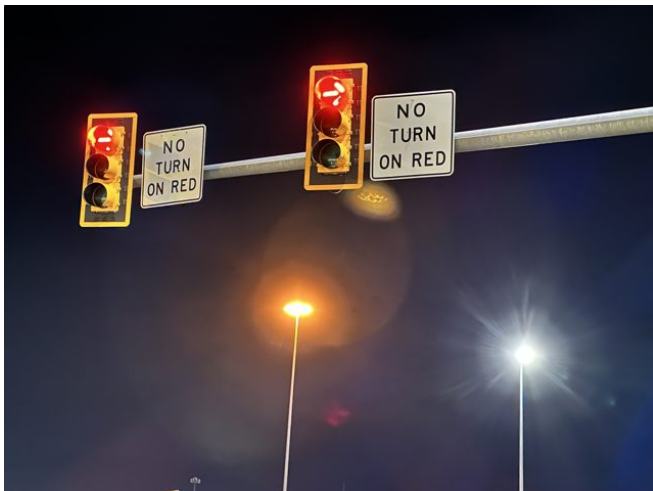
**Photo 3**

Close view of the left-turn signal heads.

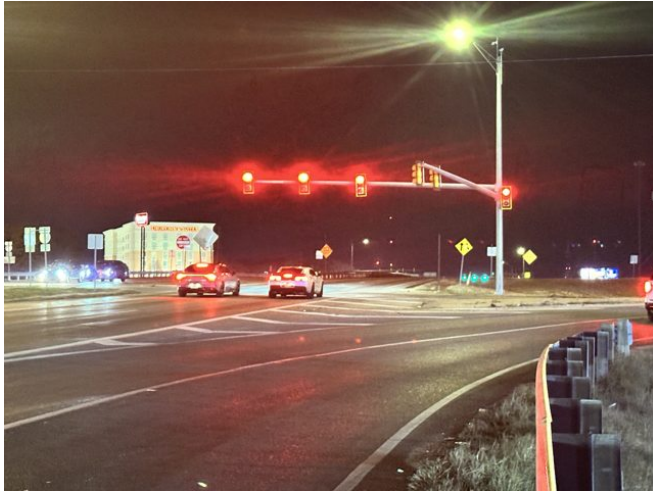
**Photo 4**

The signal heads spanning the intersection, photographed the evening of the accident.

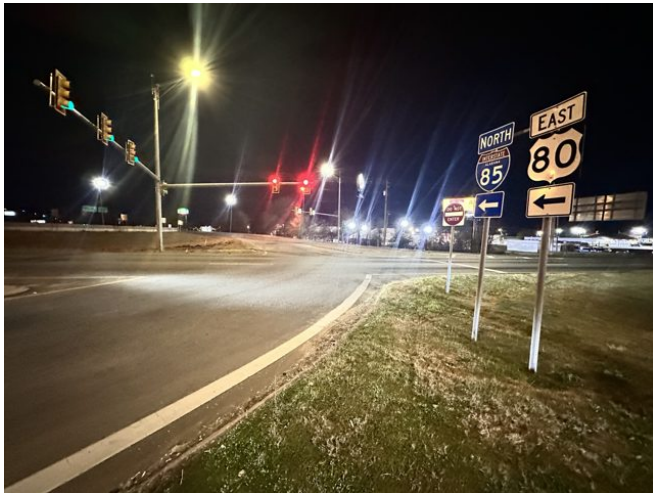
**Photo 5**

Entrance lane to I-85 North / US-80 East at the turn.

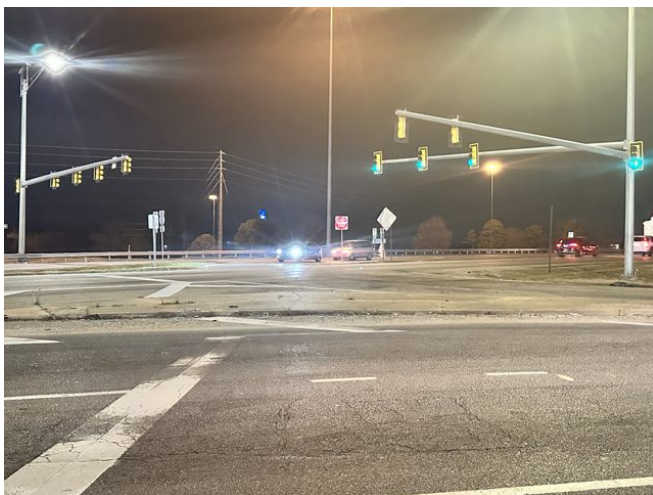
**Photo 6**

The intersection from the corner, showing the lane layout and signal mast arms.

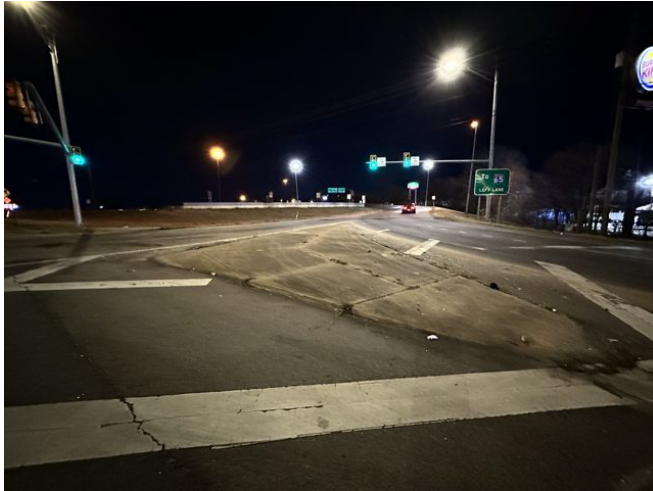
**Photo 7**

The concrete island curb at the intersection.

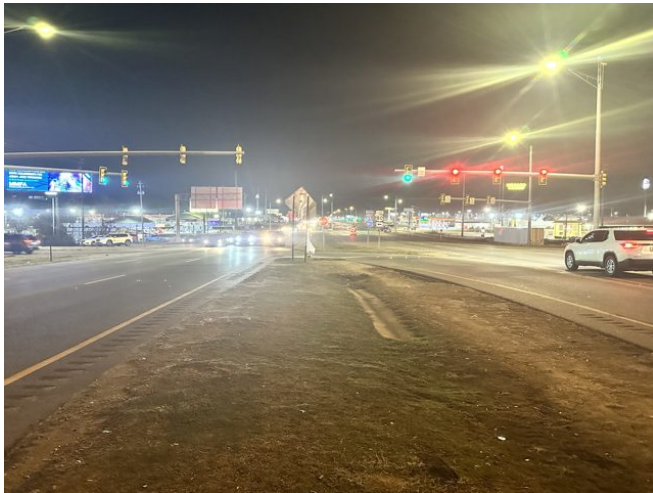
**Photo 8**

The grassed center median of Eastern Boulevard, with tire tracks visible.

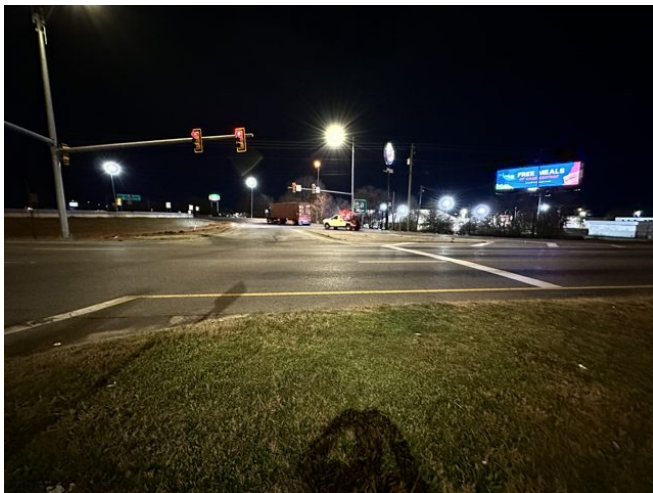
**Photo 9**

Looking across the intersection, showing the sight lines for approaching traffic.
