## Final Loss Report (sample)

| <b>Insured:</b> | [Removed] | <b>Date of Loss:</b> | 9/11/2017 |
| <b>Location:</b> | DeKalb County, GA | <b>Type of Loss:</b> | Wind (Tropical Storm Irma) |

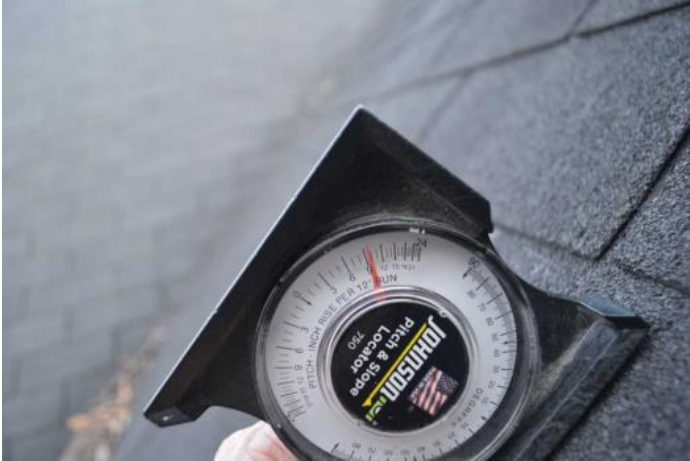
**Photo 13**

25-year shingles, no drip edge, two layers. Georgia code now requires drip edge and valley flashing (IRC R905.2.8.5 and R905.2.8.2)
